I 1.5.5 ECOLOGY REPORT

Redcliffe Quarter
St Thomas Street
Bristol

A Preliminary
Ecological Appraisal
By:

June 2021

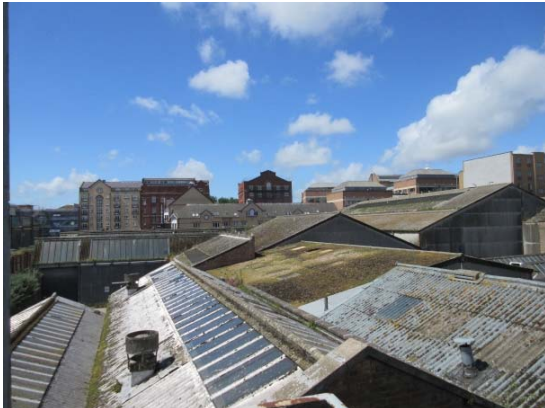
Plate 5: View from eastern end of site across roofs

- 6.2 During the 2015 survey it was difficult to be precise with respect to the materials used for the roof coverings of some of the warehouse sections, due to their height, absence of access, and a failure to get any reasonable view of the roof from a close vantage point.

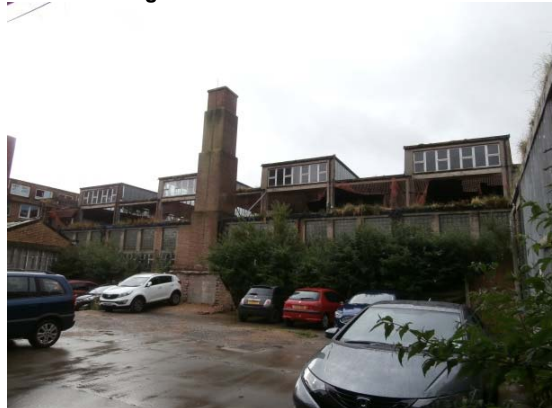
Plate 6: Pilkington warehouse

- 5.3 A garage and restaurant were the main businesses still operating on site. These were at the south-western and north-eastern ends. There were also a two open areas within the block, which were used for car parking and storage, as well as a short access road to the car parking area. One building, the Pilkington glass site, had a basement, as well as office space above. At the south-eastern corner of the site, water had ponded on the roof of a small section.

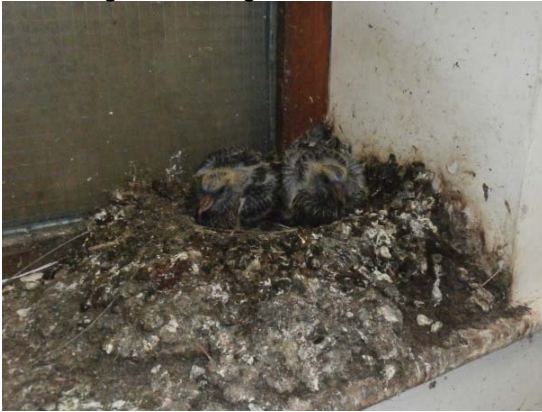
Plate 9: Pigeon hatchlings

- 8.3 Birds were observed and heard on site during the survey, and evidence of breeding was found by way of an active nest with two hatchlings present. House sparrow were seen and this species appears on the red list of the British Trust for Ornithology (BTO) 'Birds of Conservation Concern' reflecting the decline in the population in recent years. Herring gulls have been added as a red list species due to the same reason. Nesting efforts of all wild birds are protected under Schedule 1 of the Wildlife and Countryside Act 1981 (as amended) and once a nest is established it is an offence to disturb or destroy the nest. Recommendations were made concerning nesting birds.

- 9.1 When assessing the ecological features of the site against the development proposals, there is the risk that the demolition work will be constrained by the presence of breeding birds. Birds are protected under the provisions of the Wildlife and Countryside Act 1981 (as amended), and active bird nests cannot legally be disturbed or destroyed. If a nest is established the adult birds must have unrestricted access and the nest cannot be moved or destroyed until the chicks have fledged, and the nest is no longer in active use. To avoid active bird nests from disrupting demolition programmes, it is best to plan such work to avoid the nesting season which commences in March and continues to August inclusively.

- 9.3 The buildings can be checked by a suitably qualified ecologist immediately prior to demolition work commencing, but if an active nest is found, then this part of the site must be left intact. The birds must be able to access the nest, and the chicks fledge. If a nest location is discovered and rendered exposed by initial demolition works, then it may be necessary to give the nest site some screening to protect the young birds from predation. This course of action runs the risk of partial demolition being accomplished, but the final phase not being completed until the bird nesting season is concluded.

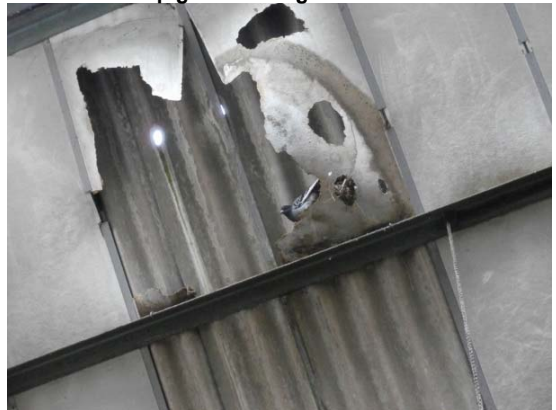
Plate 12: Feral pigeon nesting

- 1.4 During the 2015 survey, birds were noted to be gaining access into the majority of the site and breeding was occurring. Four species of bird were seen or heard inside the buildings, and regular perches inside the buildings were evidenced by bird droppings. Small animal bones around the roof parapet were considered likely to be associated with the activity of feeding seagulls. Several bird species were likely to be making use of the buildings during the nesting season. Guidance was provided concerning the legal status afforded to breeding birds and also recommendations for site enhancements for bird species.

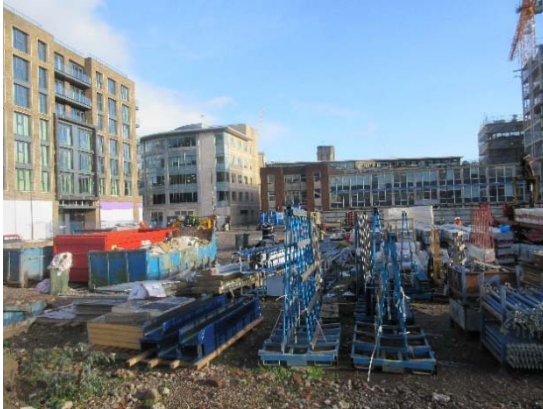
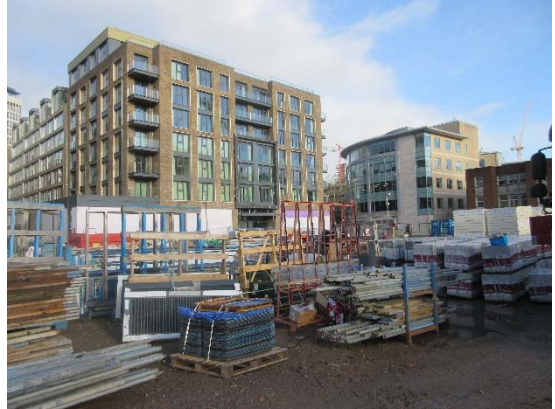
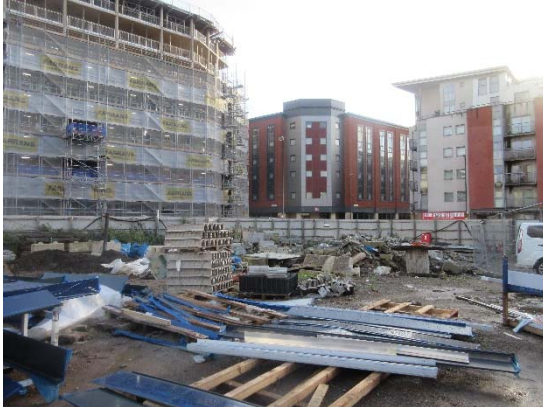
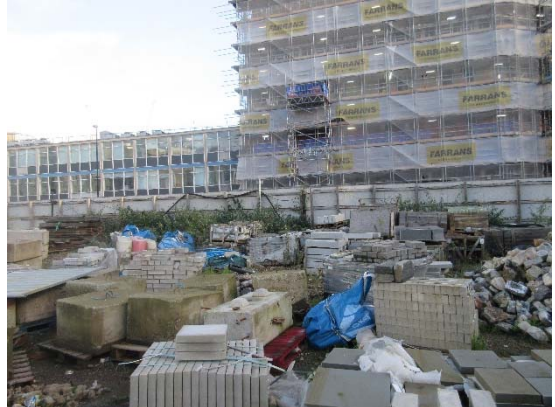
- 7.7 The update survey in 2020 revealed that the buildings previously present on site had been demolished. The site was now being used as a compound for the development proposals on the wider site, including the area beyond the site to the north.
- 7.8 Hard-standing is covering the site, a variety of structures are present on site, mostly Portakabins. The site was fenced around the perimeter and divided into sections, such as car parking etc. There were few botanical species on site. Species present included Canadian fleabane (*Erigeron canadensis*), butterfly bush (*Buddleja davidii*), and herb-robert (*Geranium robertianum*). A mound of gravel and earth was present, approximately at the centre of the site.

- 8.4 No habitats of ecological value were present on site at the time of the 2020 appraisal. All buildings on site had been demolished and the site was constantly disturbed. No areas where protected wildlife could shelter were present. Changes from the 2015 survey obviously relate to the buildings having been demolished. No new habitats, including those of ecological value had been created by the demolition.

- 9.8 There are no specific additional enhancements or survey requirements following the 2020 re-survey. However, of the recommendations outlined above, mitigation provision is strongly advised for birds, particularly house sparrow (see paragraph 9.7), as part of the development proposals.
